Report No. UT-04.26

**TECHNOLOGY TRANSFER OF
FIBER REINFORCED POLYMER
(FRP) COMPOSITES USED FOR
BRIDGE REHABILITATION AND
RETROFIT**

**Prepared For:
Utah Department of Transportation
Division of Research and Development**

December, 2004

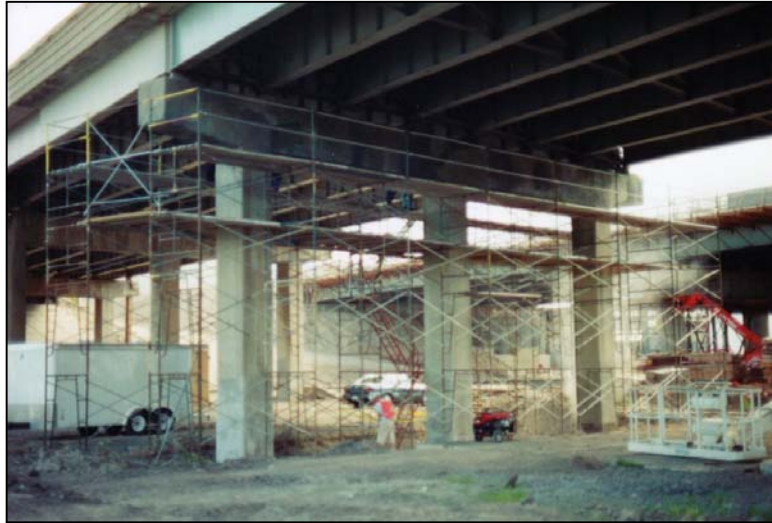
Bridge No. 58 Bent No. 6

South Bound I-15 @ South Temple

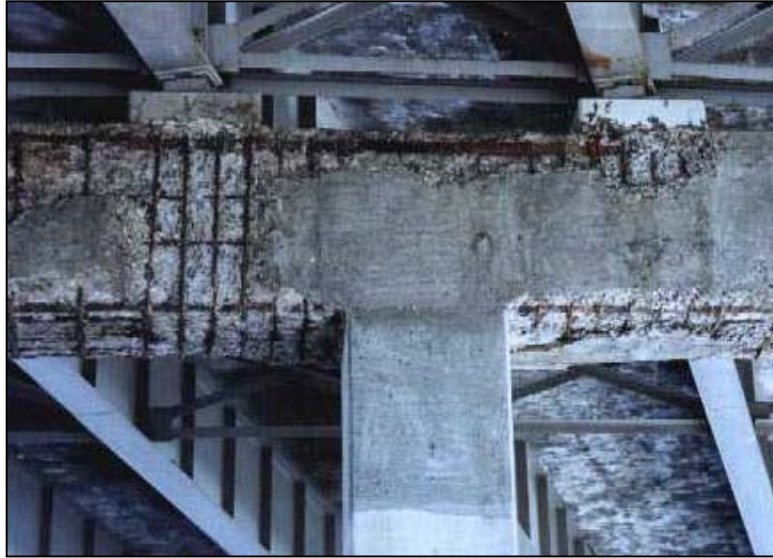
Cap Beam Showing Exposed Rebar and Spalled Concrete

Sika Corporation retrofitted 3 square columns and cap beam on Bent No. 6. The columns were 3' x 3' x 24' (0.91m x 0.91m x 7.32m) tall. The cap beam cross-section was 36" x 48" (0.91m x 1.22m). The cap was 64.5 feet long (19.67m). This report starts with details of initial condition of the bridge. The detailed design, materials used, cost of materials and procedure are included later in this report. Condition of the Bent
The bent had large cracks and holes in the concrete column in the areas to be retrofitted. Concrete had spalled off leaving holes approximately 1' x 4' (0.31m x 1.22m) at the corners. Rebar was exposed on the cap beam. Shot Crete was applied to restore the cap to its original dimensions after all loose concrete was removed with water blast.

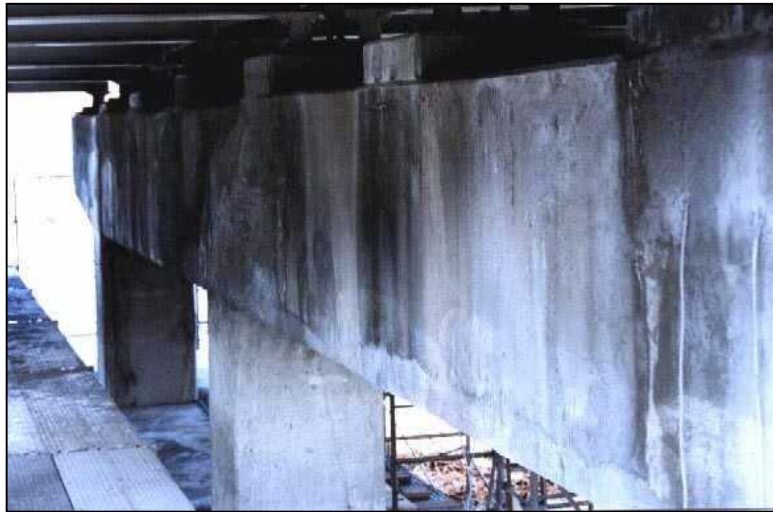
Cap Beam Repaired with Shot Crete

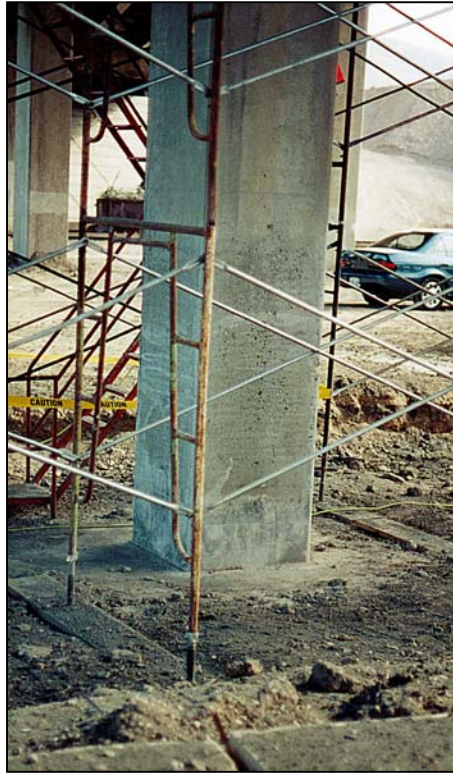
Repaired and Cleaned Column

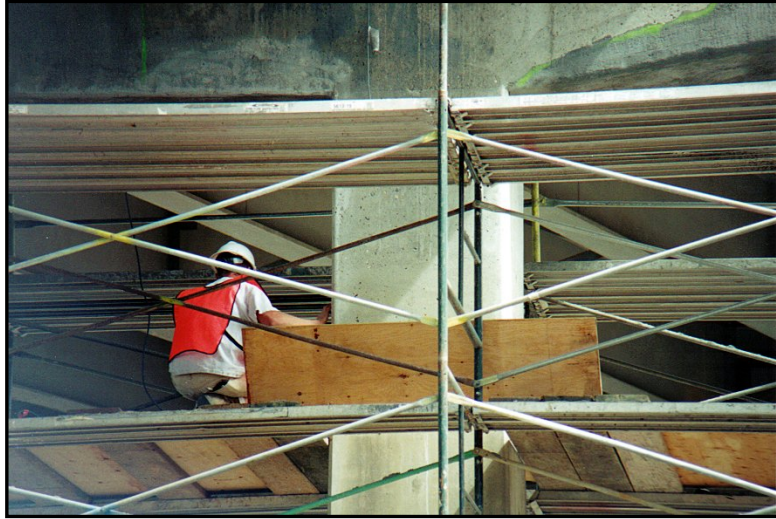
Cleaning Column

The first step for a successful retrofit job is to clean the concrete structure to ensure good adhesion between the adhesive and concrete. This was accomplished by using water jet blasting. Since the water jet was done one week before the columns were repaired, the surfaces had to be ground and brushed off to remove dust. The profiling material, Sikadur® 31 Hi-Mod, high strength structural adhesive, was used to patch large voids. All corners of the columns were rounded and smoothed using the grinders. After cleaning, patching and grinding, the columns were marked where the carbon fabric needed to be laid down. In the case of columns, the wrap started 2" from the top of the footing and 2" down from the column-cap joint.

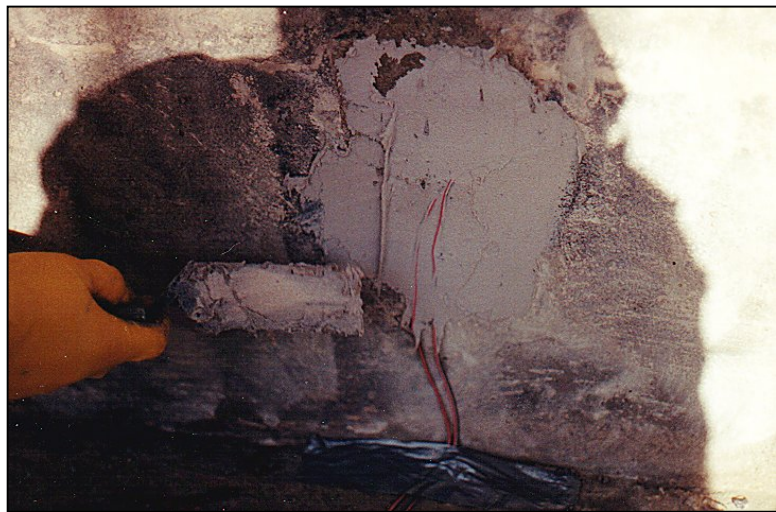
Applying Sikadur® 31

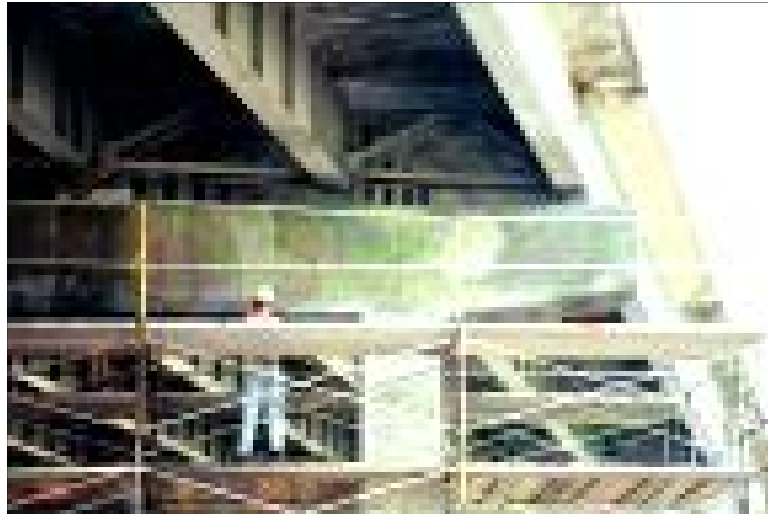
Pattern Layout Prior to Repair

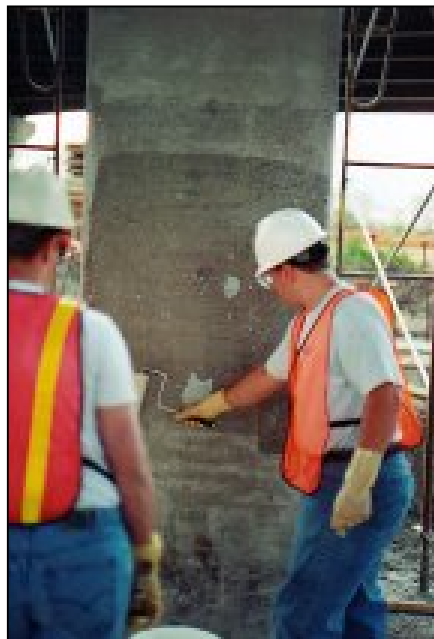
Base Resin Application

The final step in preparing the columns was to coat the area that would accept the carbon cloth with Sikadur® Hex 300 Impregnating Resin. This is the same resin that is used to impregnate the carbon cloth. The reason the resin is applied is to give the impregnated carbon cloth a better bonding surface. It should be noted that Sikadur® 31 structural adhesive was not used to facilitate bonding to the concrete substrate.

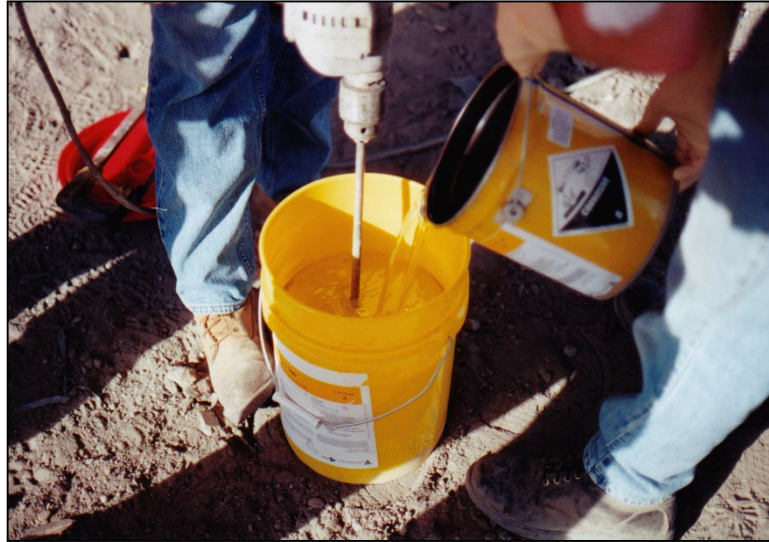
Mixing “A” & “B”

The contents of container “B” are poured into container “A” and the mixture is mixed for 3 to 4 minutes. This is the manufacture’s recommended procedure and corresponds to typical industry practices.

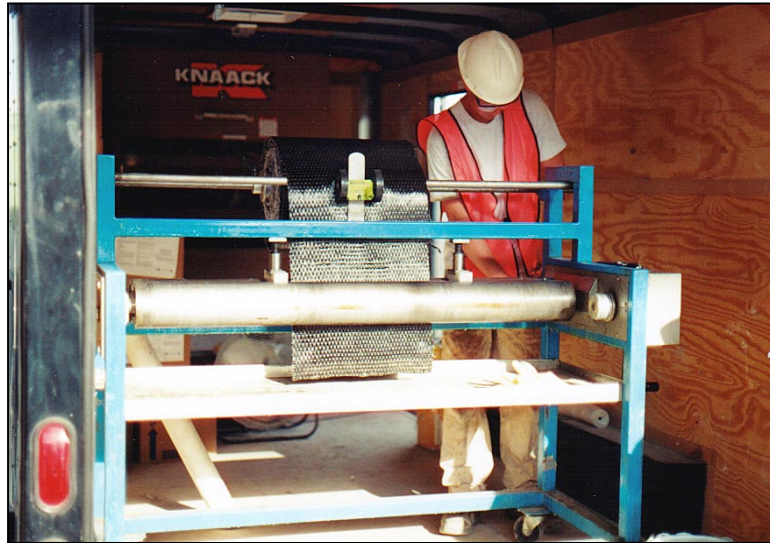
Saturation Unit

Once the resin has been mixed, the carbon fabric is impregnated. Sika used a saturation machine for this purpose. The saturator is a machine with two rollers that combines the resin and fabric. This method is very efficient. The saturator is calibrated for the resin viscosity, fabric weight, temperature and fabric width. The fabric is loaded on a let-off and passed through the two saturation rolls. This action forces the resin into the fabric and eliminates the possibility of having dry fibers appear in the finished composite jacket. The machine is manually operated and is suited for a construction environment. Once the desired length of fabric has been saturated, the material is cut off using scissors.

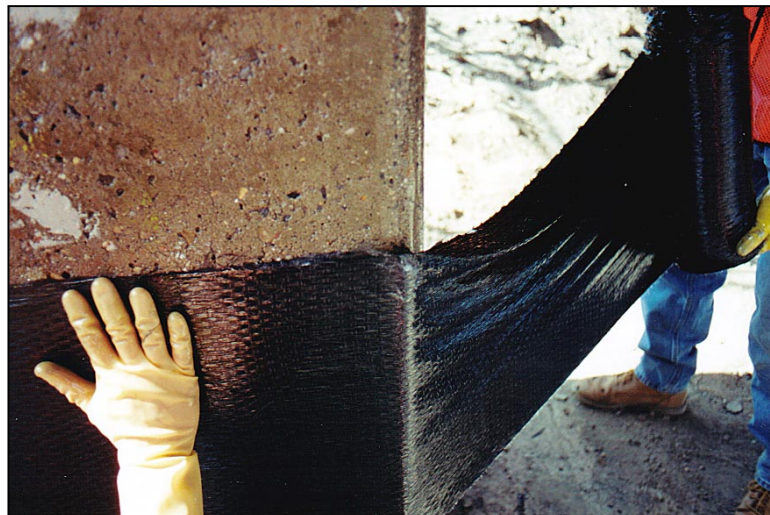
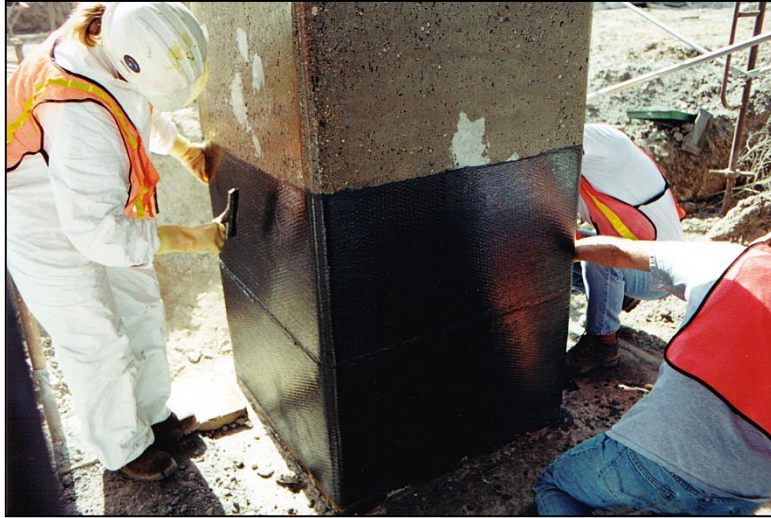
Applying Material in “Jelly Roll” Fashion

The “jelly roll” method, although saving time, may have been partially responsible for some void problems that occurred in a later phase of this project.

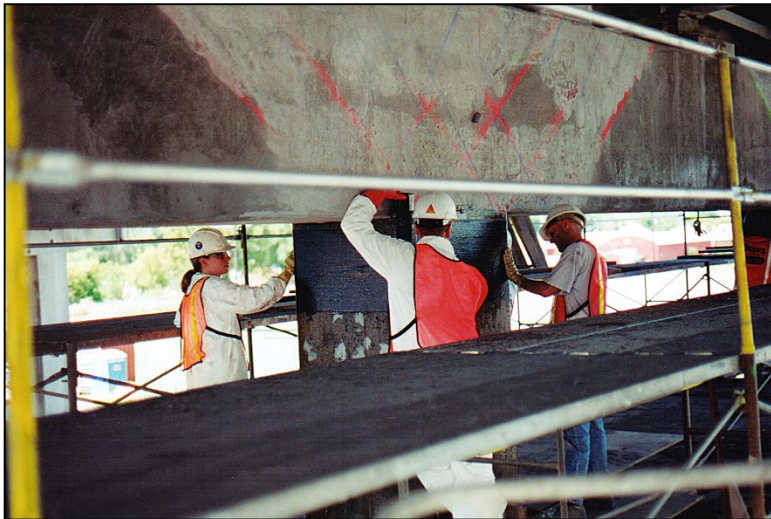
Applying Carbon to Upper Portion of Column

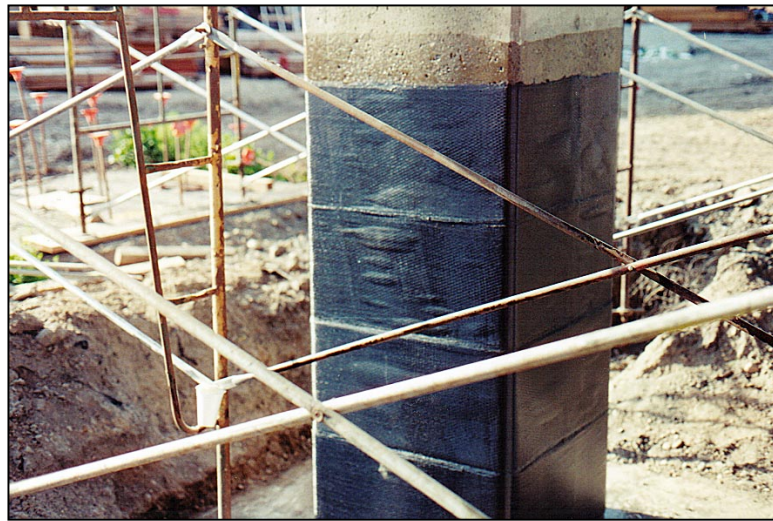
On the second day, the lower portions of the columns were inspected prior to the installation of the remaining layers of carbon. Upon inspection it was noticed that there were a number of voids found in the jackets particularly on the east and west columns that were exposed to direct sunlight during cure. These voids were of various sizes, from small (the size of a quarter) to very large (20 in² to 30 in²). This defect had to be addressed prior to proceeding with the remaining wraps of carbon cloth.

Voids in Jacket

There are several possible reasons for the voids forming in the jacket. It should be noted however, that voids in a confinement application are not necessarily bad. Although this problem does not look good there should be enough strength in the repair area to insure a long enough development length to assure proper bonding between layers.

- Jelly-roll installation process. This has been noted on other retrofit jobs.

- The resin, Sikadur® Hex 300, has a long gel and cure time. This could cause the fabric to “bag” under its own weight and cause layers to separate.
- The use of a structural adhesive as the first layer on the concrete was not done. Normally, flat surfaces, even on square columns, are treated with an adhesive prior to installation of the carbon material.
- Out-gassing from the concrete.
- Direct exposure to the sun during cure.
- Grinding was the surface preparation vs. sandblasting which would be preferable.
- Sikadur® Hex 306, which is a heavier, more thixotropic epoxy might have sealed the pores of the concrete better thus reducing out-gassing from the concrete.
- The use of a cementitious or epoxy leveling mortar on the columns before wrapping will reduce or eliminate concave or low spots and out-gassing of the concrete.

- Use of the fabric saturator is essential.
- Use of cementitious or epoxy leveling mortar on concrete before wrapping.
- Sandblast surfaces to receive composite wrap.
- Use of Sikadur® Hex 306 epoxy.
- Apply fewer wraps at a time.
- Shading composite from direct sunlight during cure.
- Covering composite with a cementitious or acrylic coating to protect it from ultraviolet light damage for long-term performance.

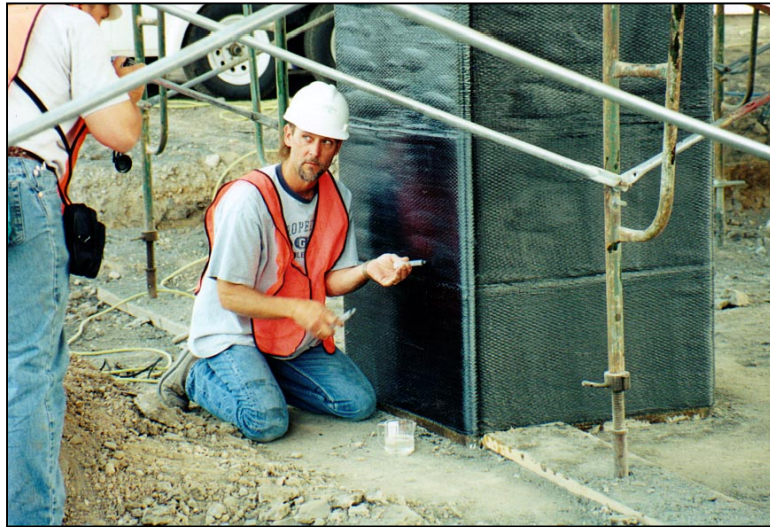
Injecting Resin Into Void

- Locate the void areas.
- Drill ~ 1/4" diameter hole in the lower and upper portions of the void.
- Inject Sikadur® Hex 300 Impregnating Resin into the voids until it flows out the top hole.
- Plug the lower hole with Sikadur® 31.
- Allow the resin to cure.

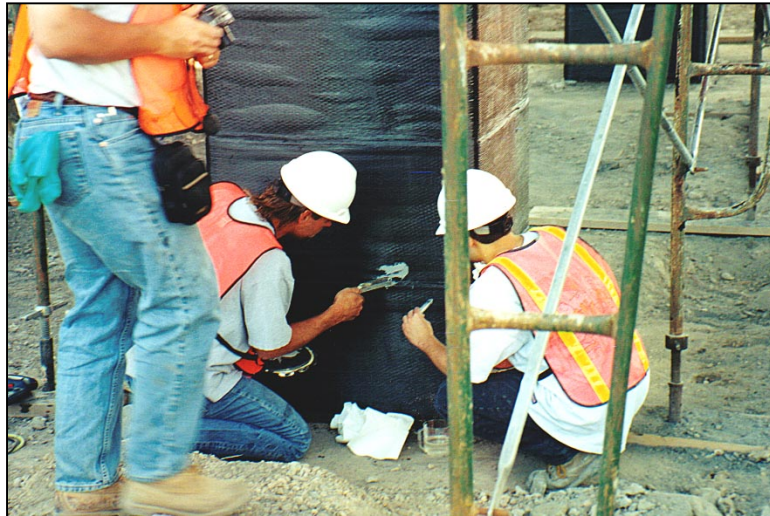
Sikadur® 31 Patching Lower Hole

The void problem required 8 additional man-hours to repair. This must be avoided in future applications because of the cost that will be incurred by the contractor.

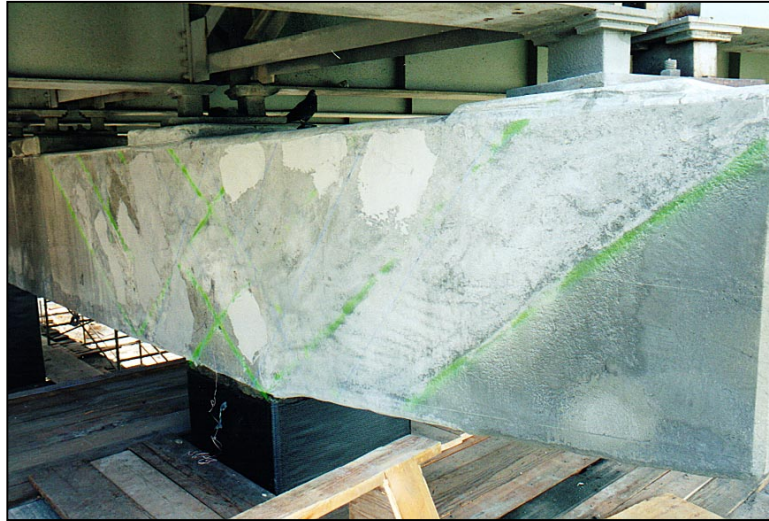
Sikadur® 31 Applied to Fill Uneven Spots

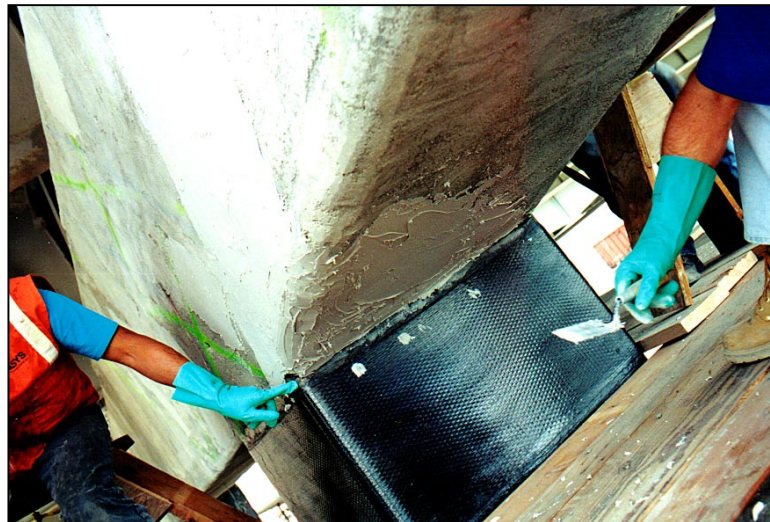
Sikadur® 31 Applied as Prime Layer to Cap Beam

This sequence of pictures is very important. The adhesion between the concrete substrate and the composite material is vital to the overall strength of the system. The loads must be between the concrete and the composite through this layer. If there are any voids on the flat surfaces the loads will not be transferred properly, thus reducing the overall strength of the system.

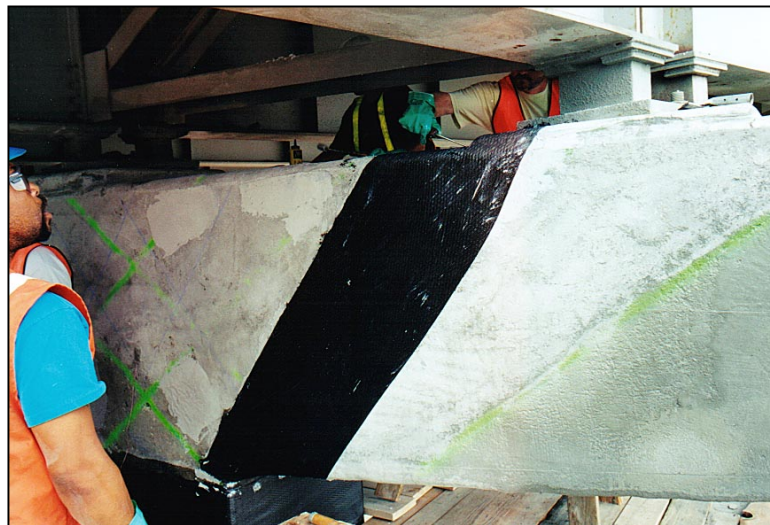
52 Degree Layer Being Applied

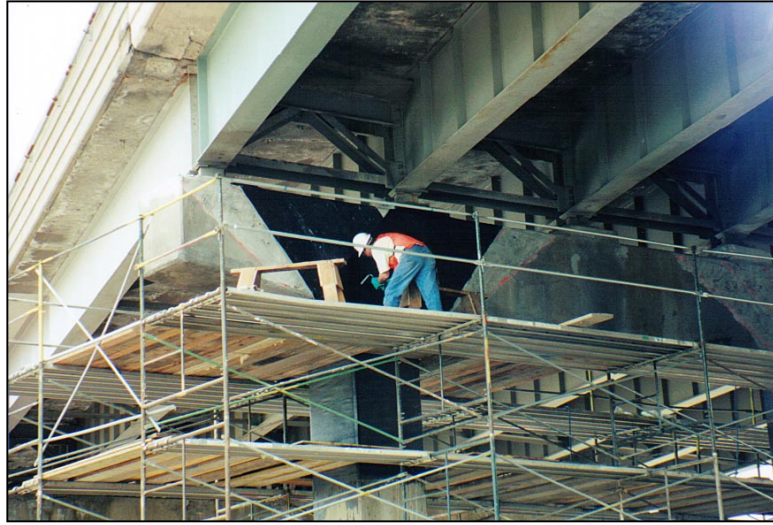
52 Degree Layer In Place

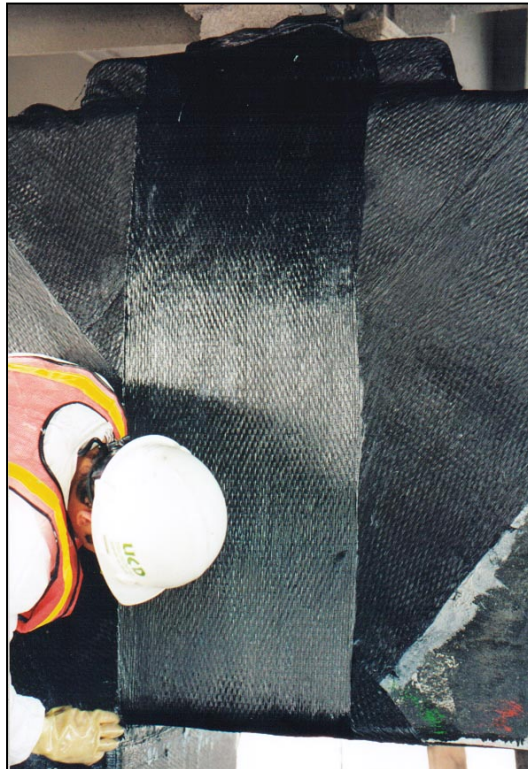
0 Degree Layer Being Applied

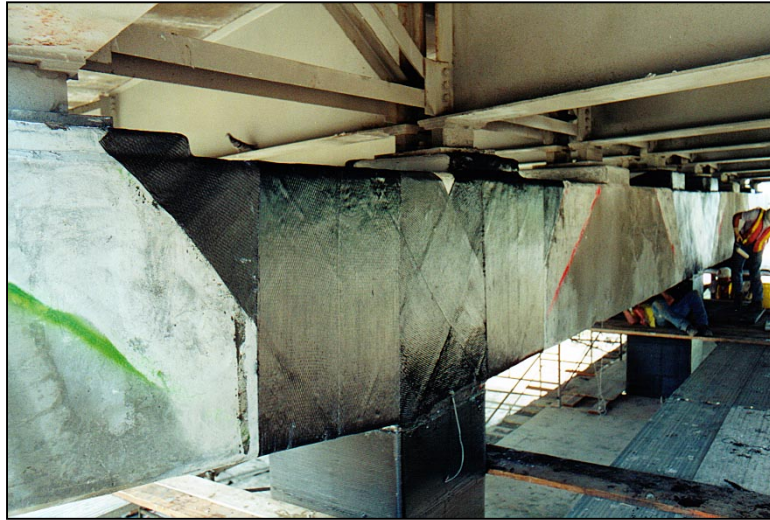
0 Degree Layer In Place

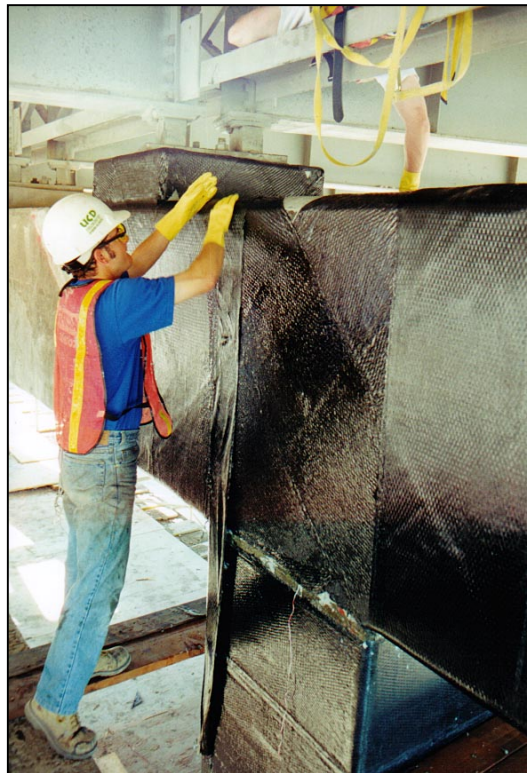
Application of Six Inch Strips

bottom of cap. The thin 6" straps are then placed as shown in the design. These begin on the column, wrap all the way across the cap and then end on the opposite face of the column. Final two layers of carbon are placed around the straps on the column surfaces to secure the straps in place.

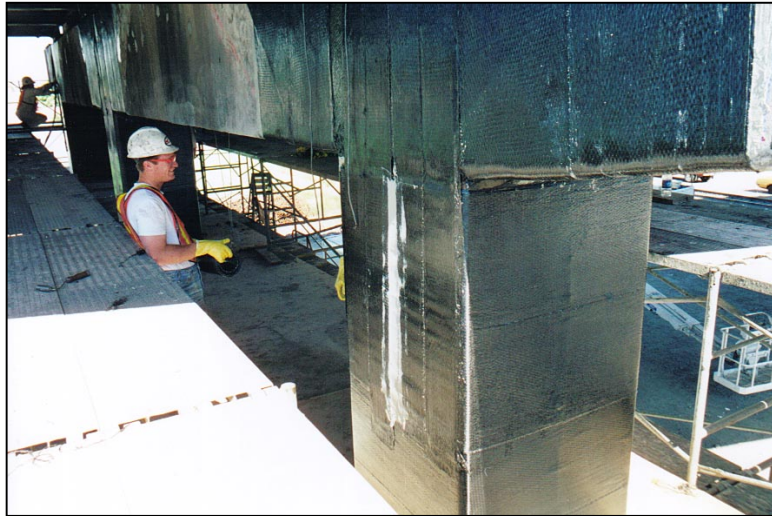
Six-Inch Strips In Place

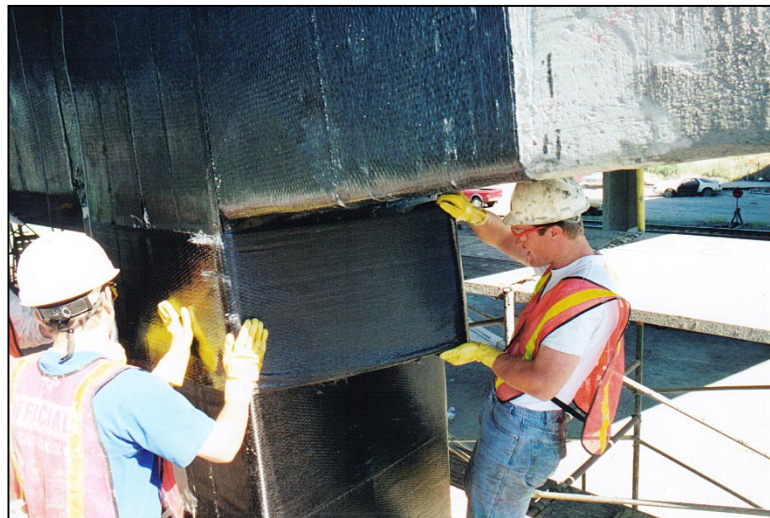
Final Layer Applied to Column to Tie 6 in. Strips Down

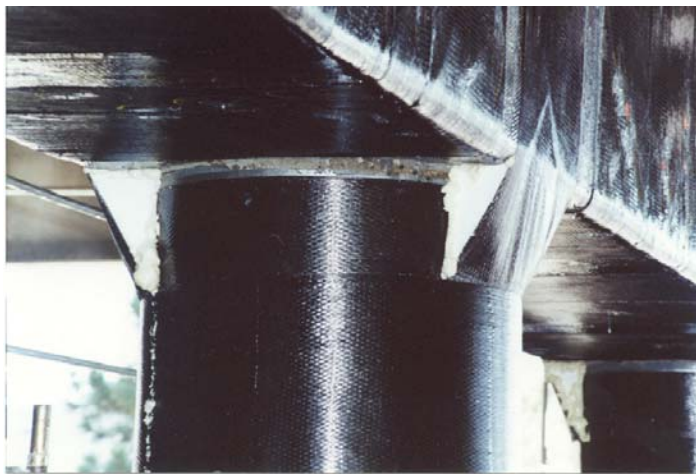
(a)

Figure 6.5. CFRP composite application on State Street Bridge bent
